# Mitigation of Dirty Electricity from Solar Inverters

## Capacitive Parallel Filters Don't Do the Job

# Mitigation of Dirty Electricity from Solar Inverter with DNA Line Filter

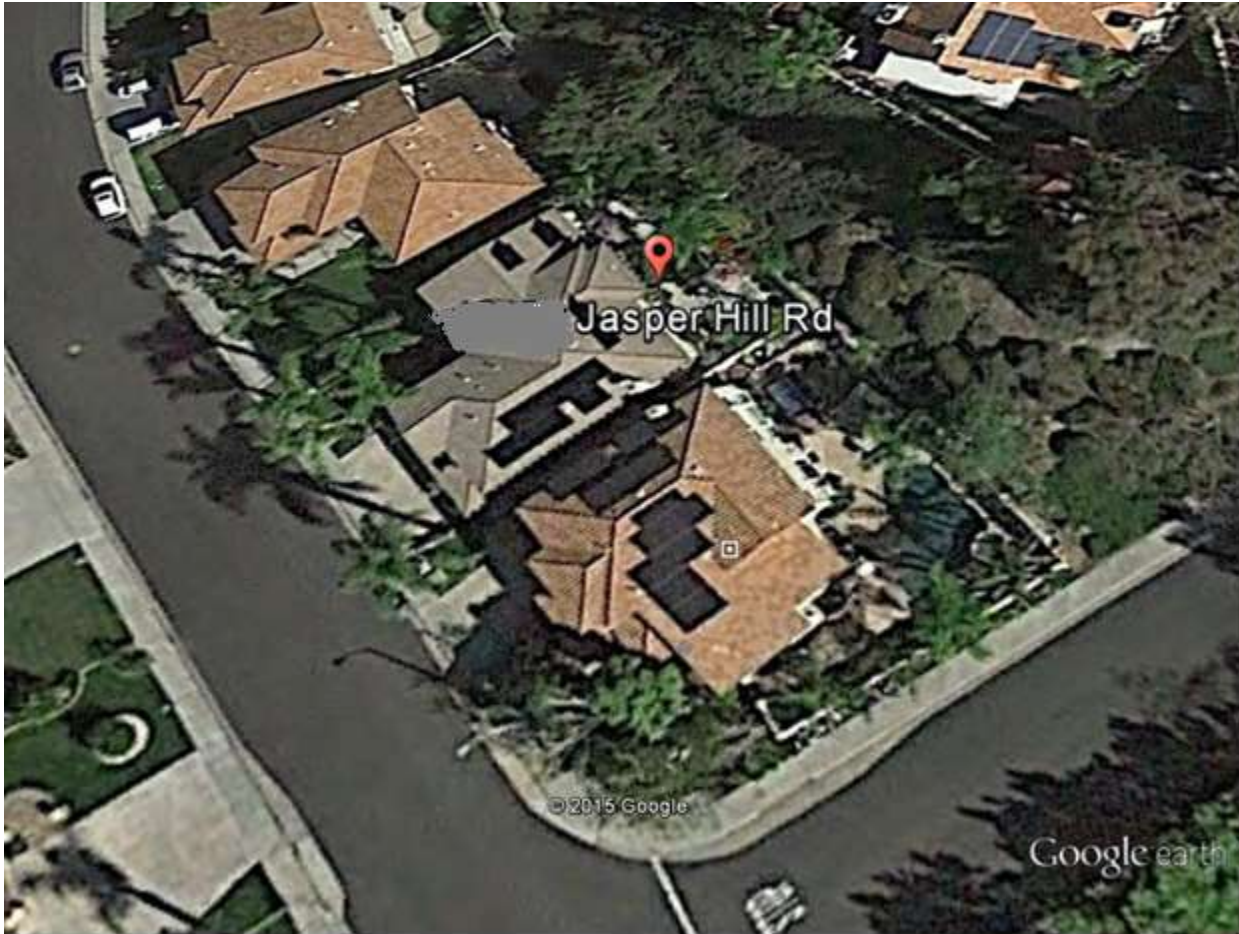
SV roof mounted panels in Trabuco Canyon CA. Main array faces SSW and 3 other arrays WSW.

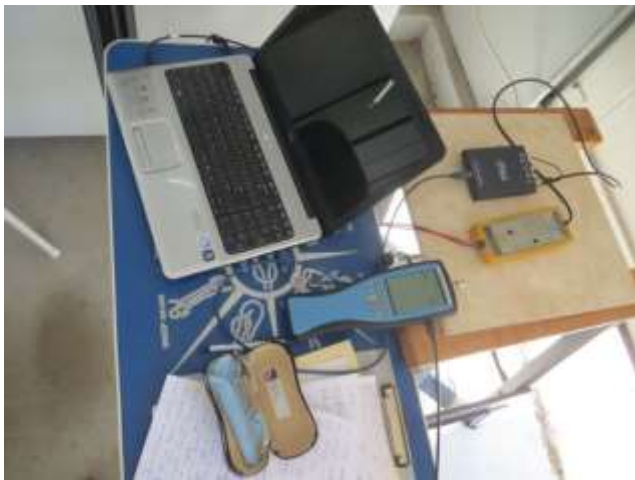
Figure 2 Laptop, picoscope and active differential probe

An instrument list is provided in attachment 1. Instrument set ups are shown in figures 1, 2, 8, 16 & 21.

Instrument setup is shown in figures 1 & 2. SV Inverter Wave Forms (measured at dedicated receptacle near power panel via active differential probe (volts = blue) to Pico-scope and laptop.

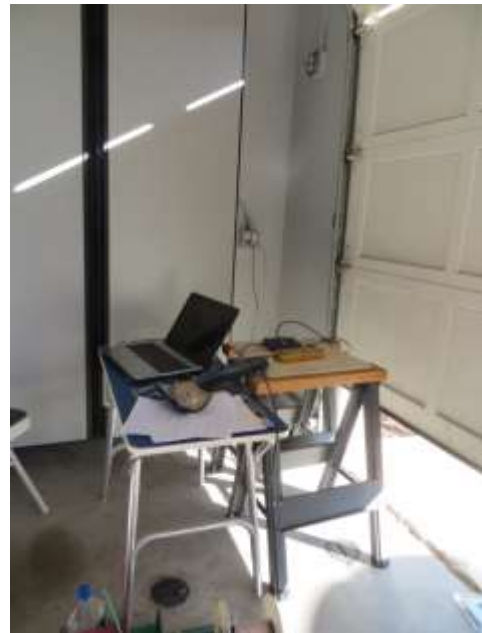
Figure 1 Instruments connected to 120 VAC receptacle

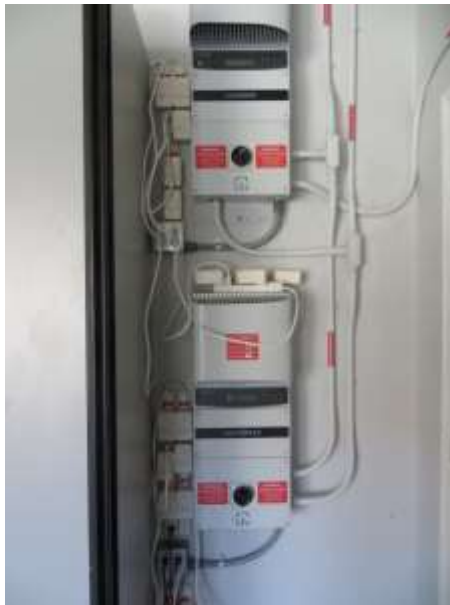
Figure 3 Solar Inverters with filters.

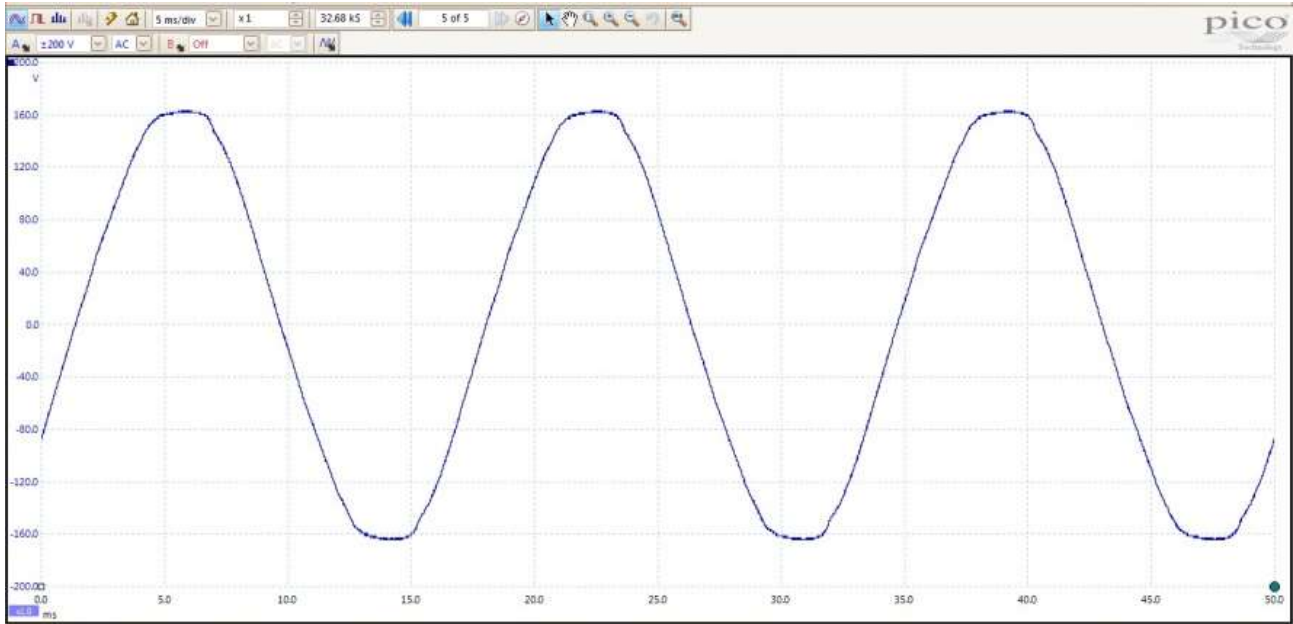
Figure 4 Inverters off. This is the typical waveform of 120 VAC from the grid.

The oscilloscope voltage waveform, figure 4, measured at the power panel receptacle location, with solar inverters stopped, appears as a sine wave, which is the expected form. When the solar inverters are running, the waveform appears as a sinusoidal saw tooth, figure 5. (Note: this waveform is abnormal and indicates that one of the inverters is malfunctioning, e.g., the voltage output of an inverter is required to be a sinusoidal form that replicates the grid per IEEE-519.) With the 19 Stetzer filters added to receptacles located at the solar inverters, the waveform compresses on the top side, still resembling a sinusoidal saw tooth, figure 6. It is easy to conclude that the Stetzer filters do not provide appropriate attenuation for these solar inverters.

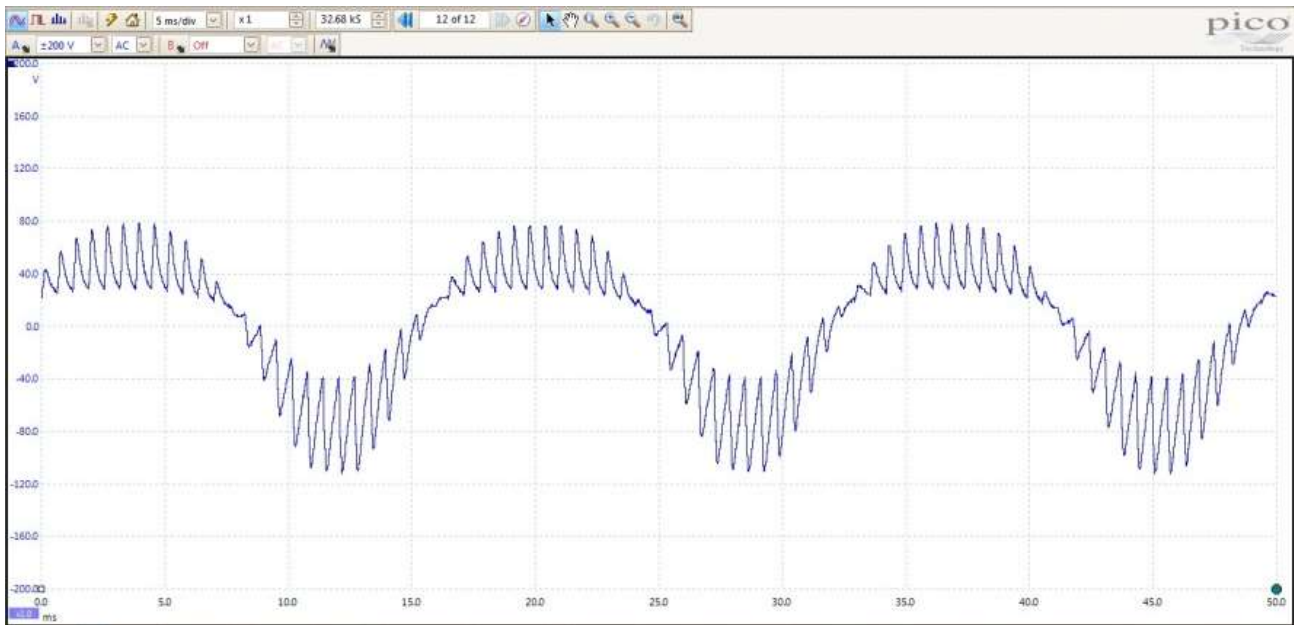
Figure 5 Inverters on. One inverter has a malfunction.

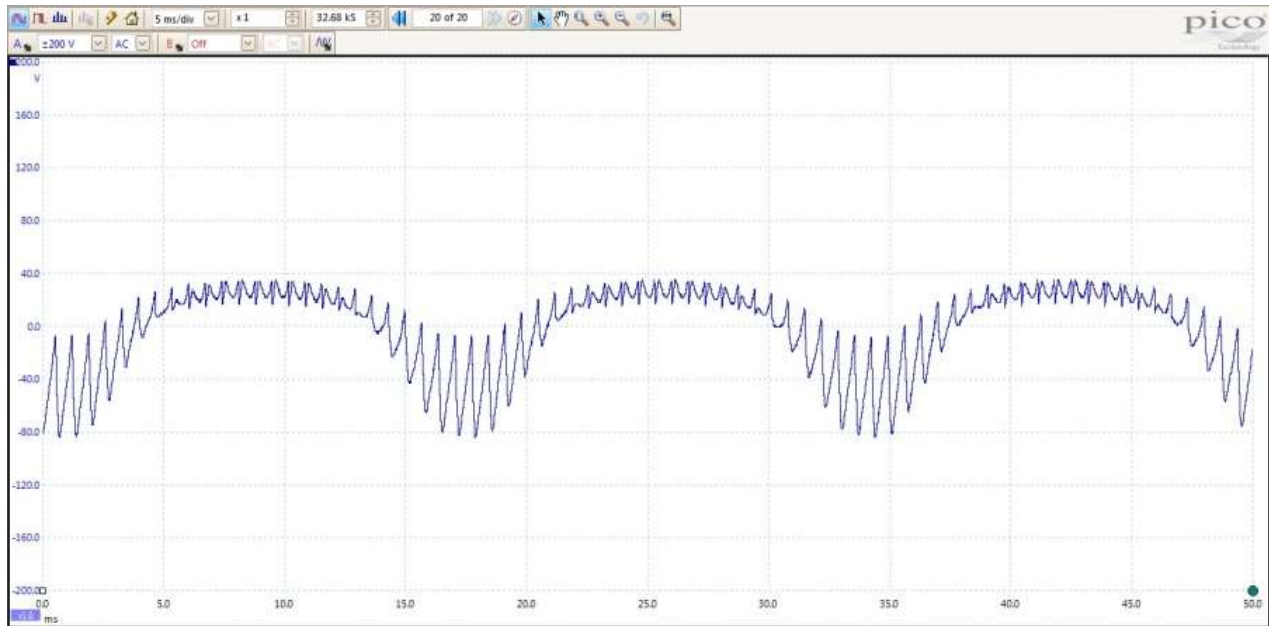
Figure 6 Inverters on with 19 Stetzer filters at inverters, the distorted waveform is not corrected.

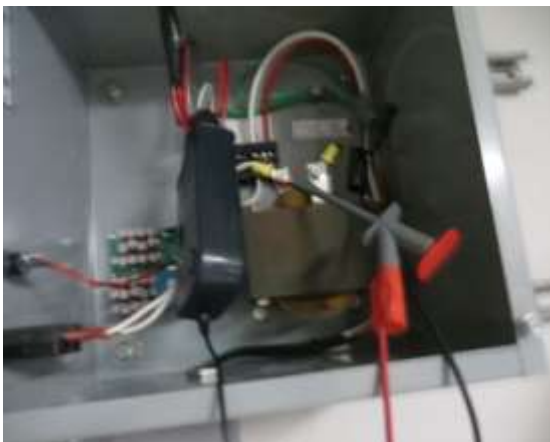
Figure 8 Test Points at DNA Filter.

Oscilloscope voltage and current waveforms were recorded, with one SV inverter operating, before and after the DNA line filter using active differential probe (volts = blue) and clamp-on meter (amps = red) to Pico-scope and laptop. The new subpanel and DNA line filters are shown in figure 7, with the hookup to the DNA line filter in figure 8.

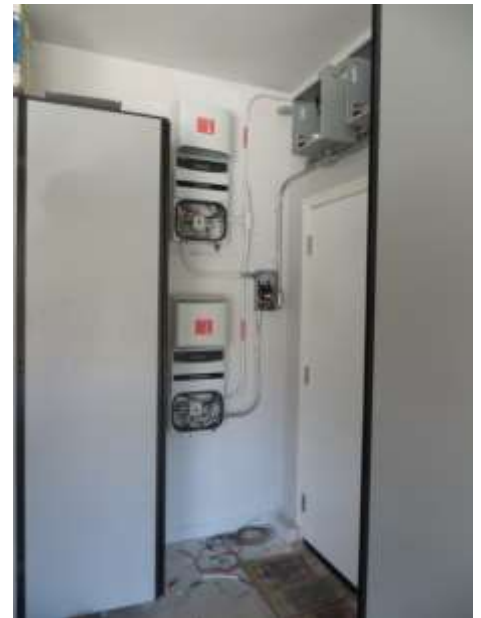
Figure 7 Inverter Sub-panel and DNA Filters

DNA line filters were installed between the new subpanel and the solar disconnect switch located near the power panel outside the garage. See figure 7 below.

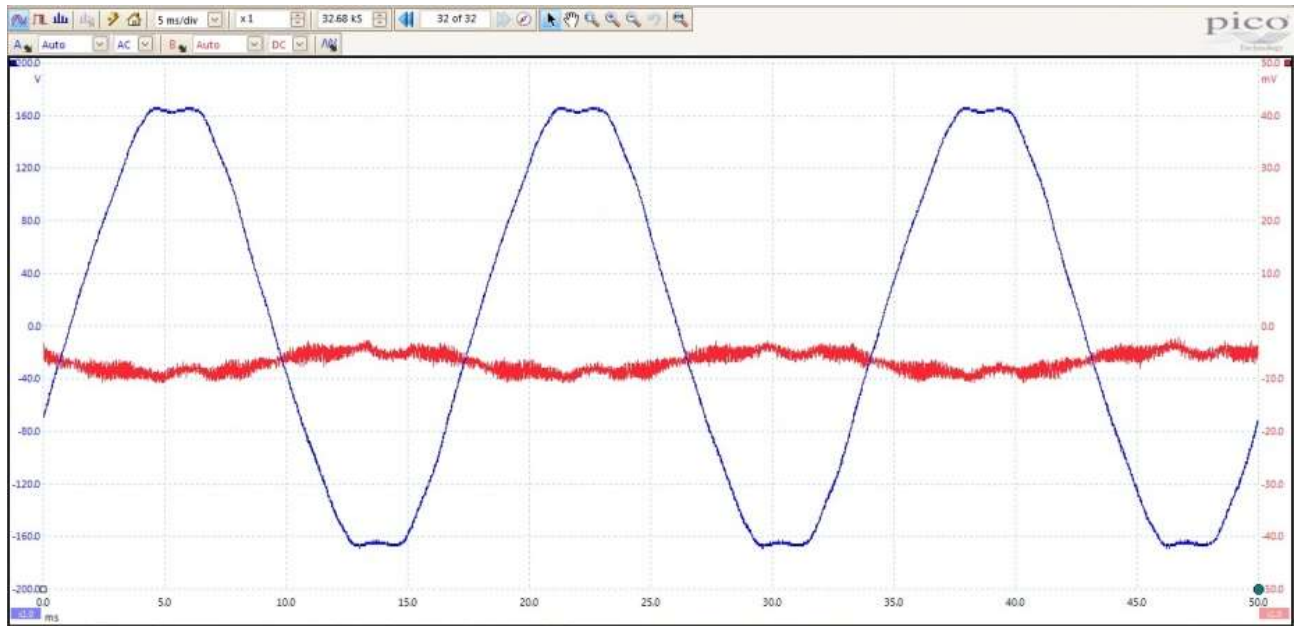
Figure 9 Waveforms from inverter at subpanel, before the DNA line filter.

**4.2.1 Waveforms:** At the inverter subpanel the voltage waveform, figure 9, is sinusoidal in shape with some distortion at the crests. The current waveform is also sinusoidal and carries multiple harmonics (EMI -electromagnetic interference) from the DC to AC conversion.

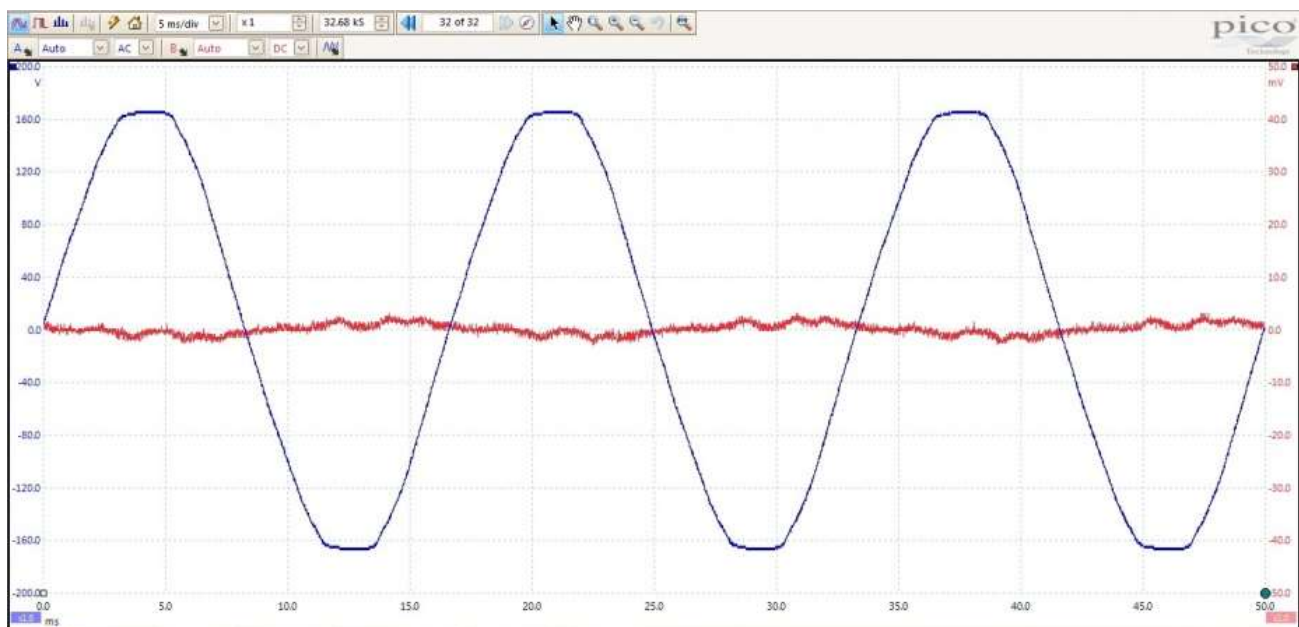
Figure 10 Waveforms from inverter at output of DNA line filter.

At the filter out, the voltage waveform, figure 10, looks just like the waveform recorded at the power panel with inverters off. The current waveform here is much smoother. Proximity of current clamp to incoming cable appears to be affecting current waveform.

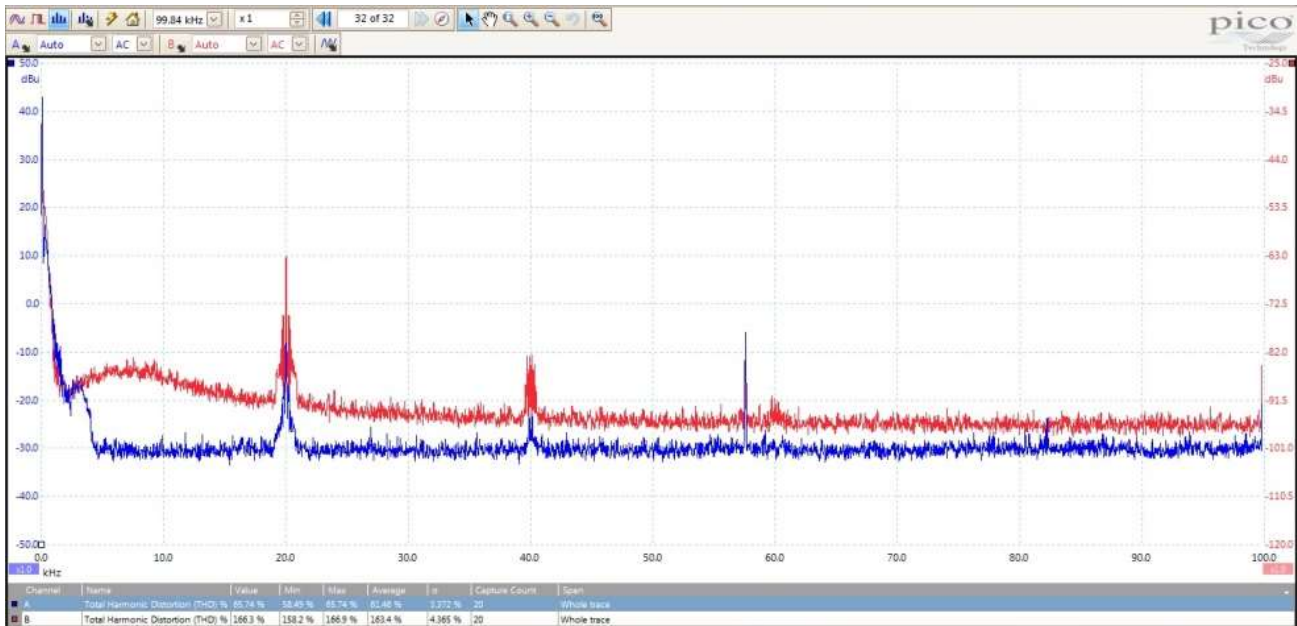
Figure 11 At inverter subpanel before DNA line filter (malfunctioning inverter off).

**4.2.2 Spectrums:** Oscilloscope Spectrums were recorded, with one inverter operating, before and after the DNA line filter using the same equipment. These are in logarithmic scale format so that the higher frequencies are not masked by the 120 VAC. The spectrum at the inverter subpanel, figure 11, shows the characteristic 20 KHz DC to AC conversion frequency and harmonics. These frequencies are gone after the DNA line filter, figure 12.

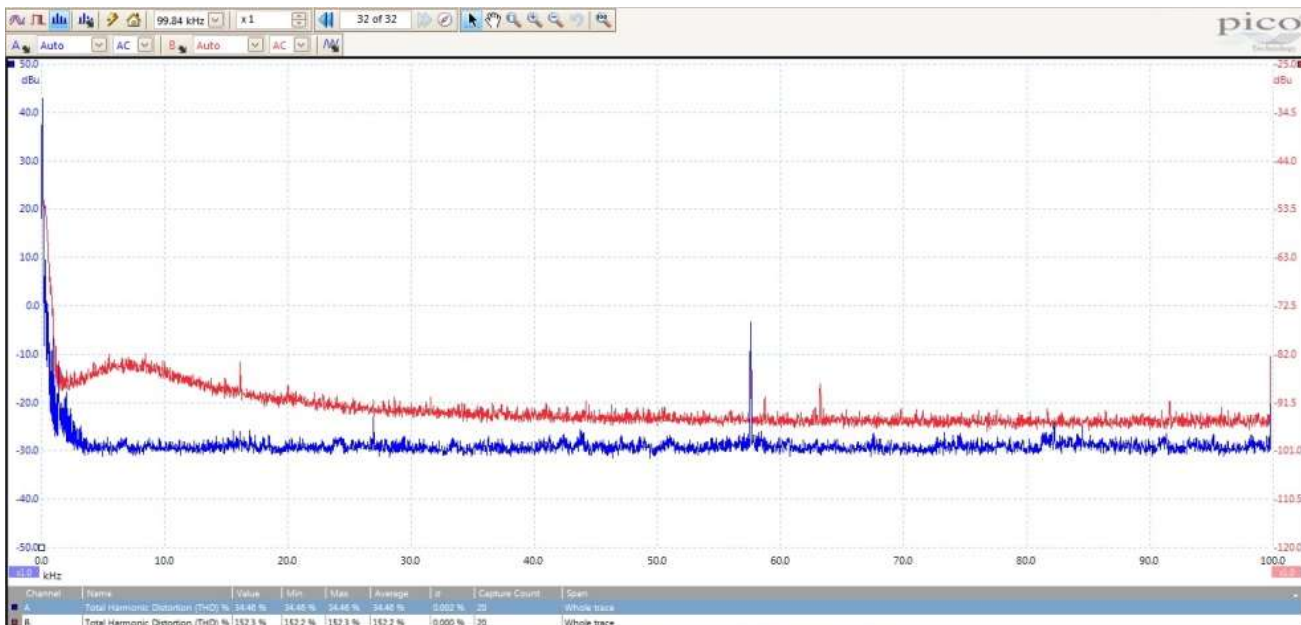
Figure 12 After DNA line filter (malfunctioning inverter off). The 20 KHz and harmonics are gone. The 57 KHz spike is from the laptop.

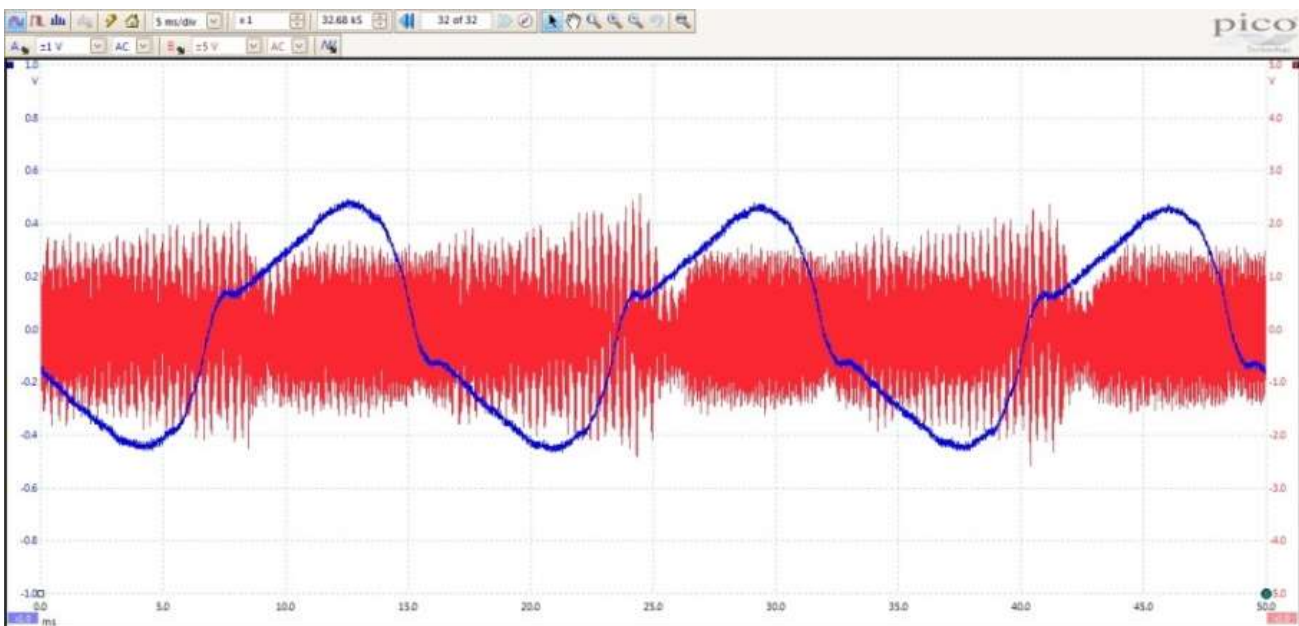
Figure 13 Solar inverters on and all Stetzer filters installed

**5.1 Oscilloscope EMR waveforms** were recorded at a 2<sup>nd</sup> story bed with the inverters running, with and without Stetzer filters in place, and with an inverter running with DNA line filter installed. EMR is the magnetic field and electric field measured on the bed with instrument setup shown in the figures 16 & 21. The magnetic field waveform (blue) is a reflection of the current in the house wiring, figure 13. It is a distorted sine wave characteristic of harmonics and dirty electricity. The voltage waveform (red) is a reflection of voltage EMI and dirty electricity in the house wiring, figure 13. The apparent level of EMI with 21 Stetzer filters in the home and another 19 at the inverters appears to be higher than with no Stetzer filters, figure 14. The magnetic waveform normalizes and the EMI is almost gone with the DNA line filter, figure 15.

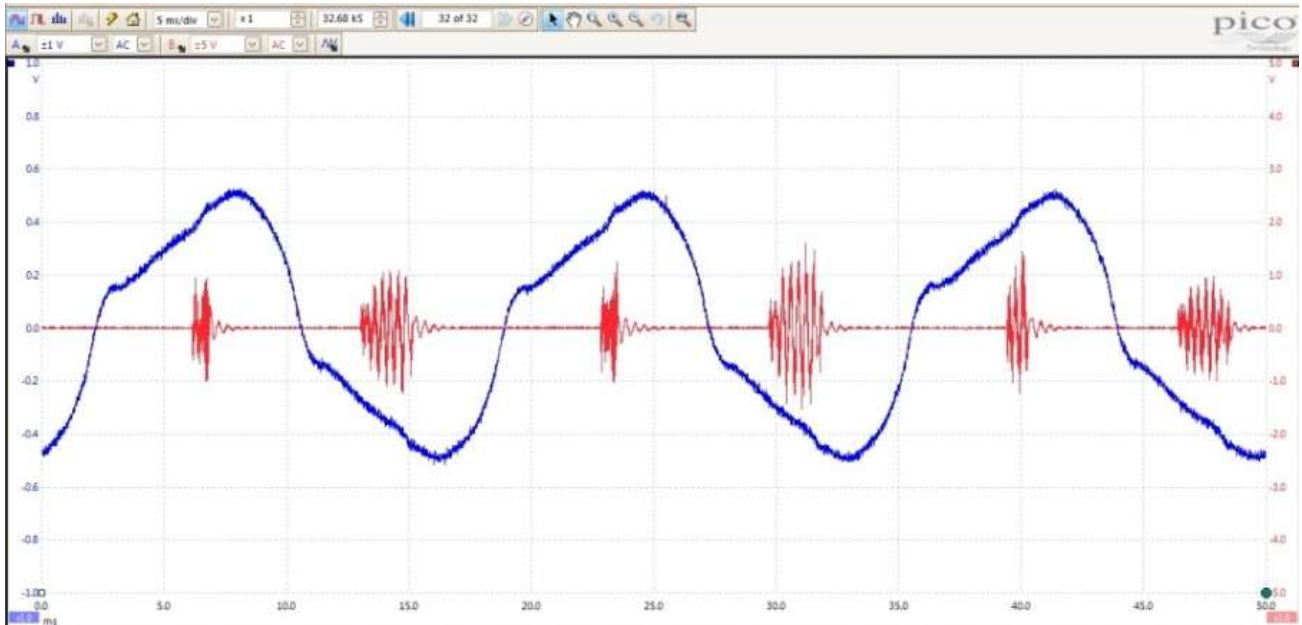
Figure 14 Solar inverters on and all Stetzer filters removed

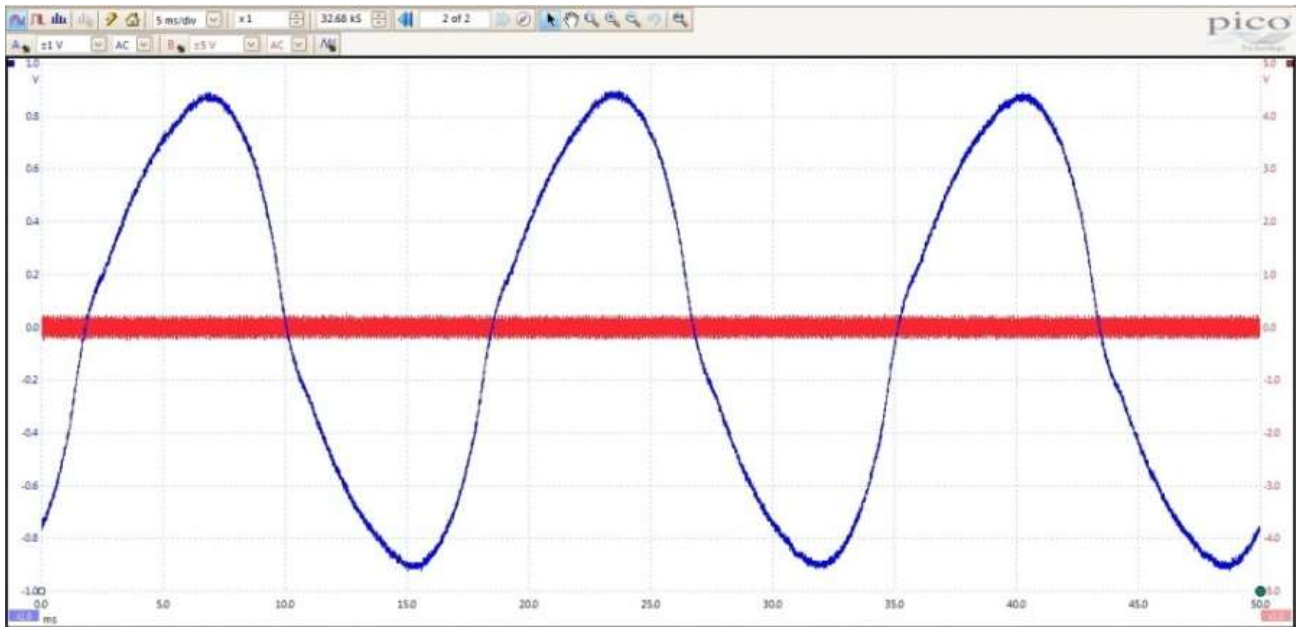
Figure 15 One inverter on with DNA line filter installed

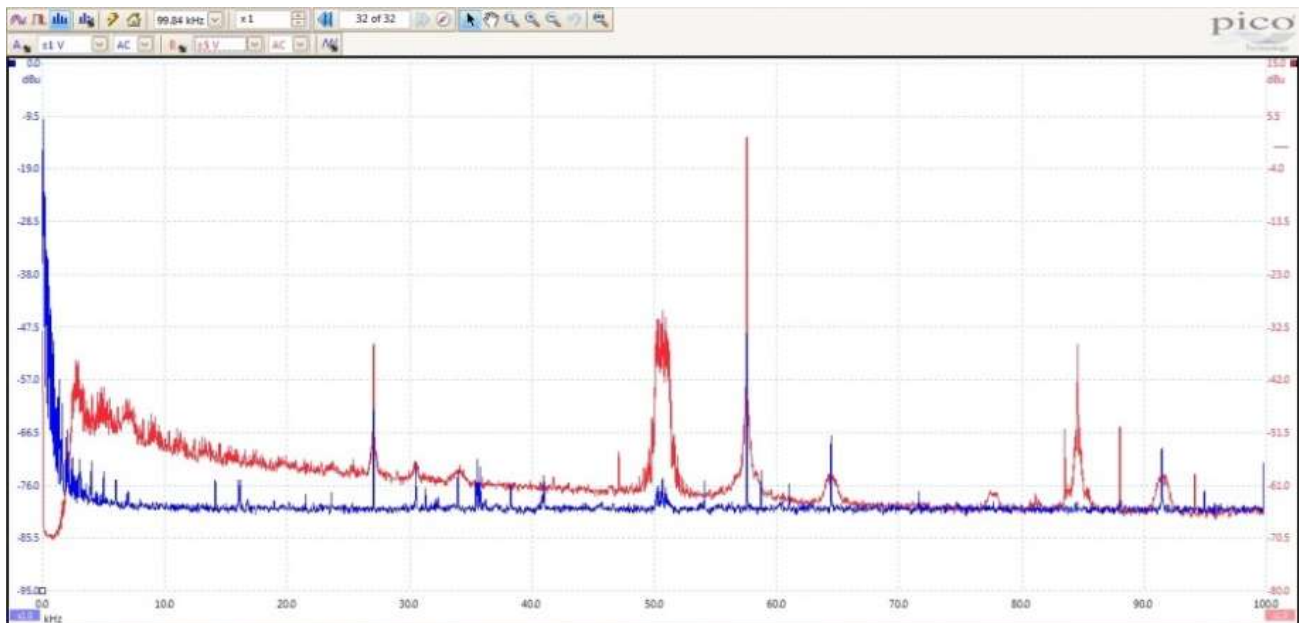
Figure 17 Baseline, inverters off and 21 Stetzer filters installed in the house and 19 filters at the inverters

The baseline spectrum, figure 17, shows harmonics associated with the grid, devices running in the house, and reactive current from the Stetzer filters (seen as harmonic peaks below 10 KHz). When the inverters are running, the EMI harmonics increase significantly, figure 18. The level of EMI with 21 Stetzer filters in the home and another 19 at the inverters appears to be higher than with no Stetzer filters, figure 19. (Note: EMI dirty electricity as indicated by the Stetzer meter decreased when the filters were installed. However, the waveforms and spectrums show an increase in the EMI harmonics with these filters.) The spectrum is similar to the baseline and the SV EMI is gone with the DNA line filters, figure 20.

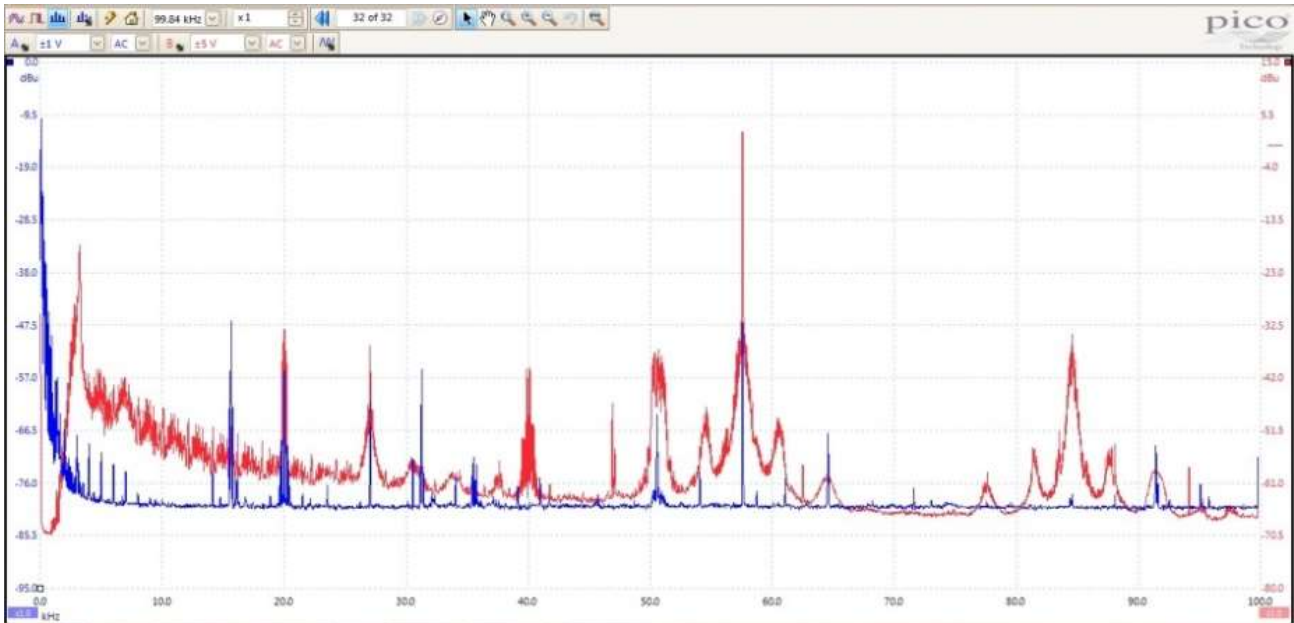
Figure 18 Inverters on with all Stetzer filters installed

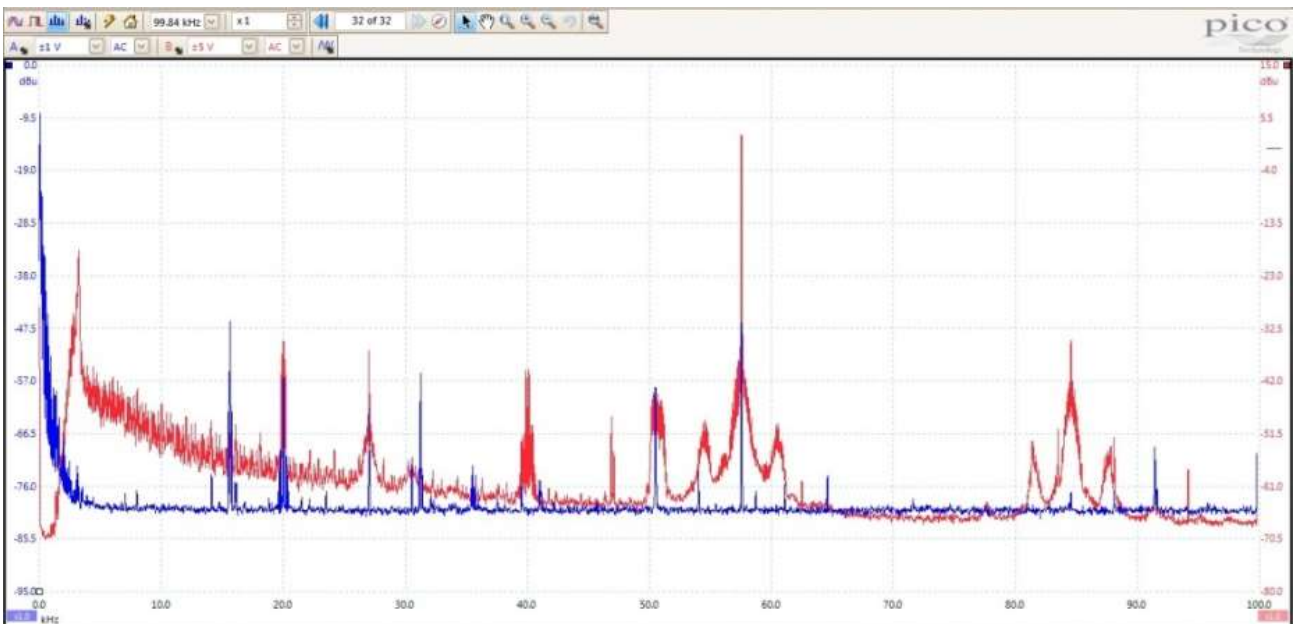
Figure 19 Inverter on, all Stetzer filters removed

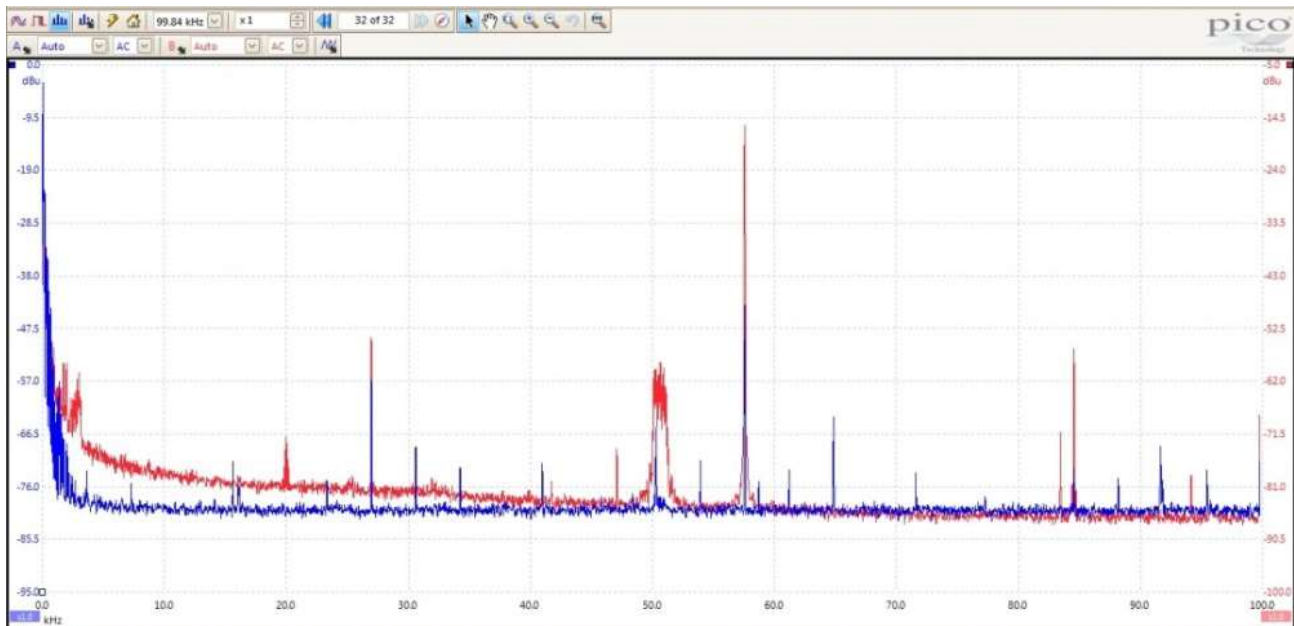
Figure 20 One inverter on with DNA line filter (Blue axis magnetic field is the same as spectrums above and the red axis electric field is 20 dB less than the three spectrums above)

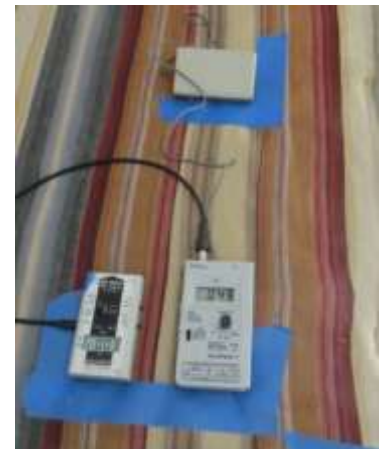
Figure 21 Instruments on 2<sup>nd</sup> story bed.

**5.3 Broadband EMR measurements** in the band >2KHz were recorded at a 2<sup>nd</sup> story bed with the inverters running, with and without Stetzer filters in place, and with one inverter running with DNA line filter in place. EMR is the magnetic (B) field and electric (E) field measured on the bed, with instrument setup shown in figures 16 & 21, and summarized in the table below (see table 1). The B Field is a reflection of the current in the house wiring. The E Field is a reflection of voltage EMI in the house wiring.

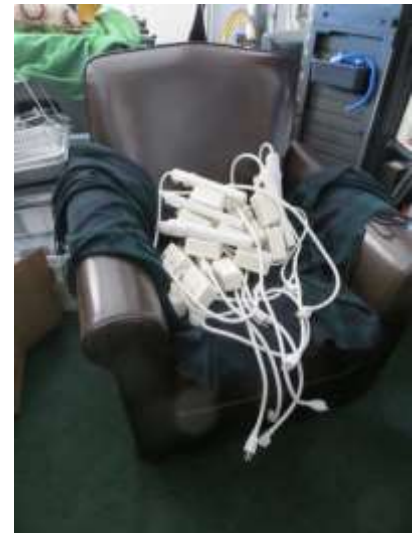
Figure 23 Removed parallel filters.

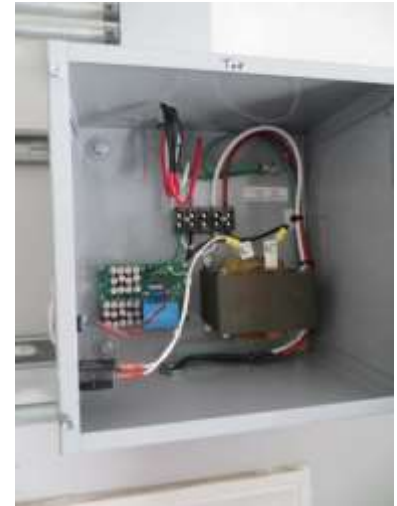
Figure 24 DNA Line Filter.

- The ambient EMR from dirty electricity can be shown as oscilloscope waveforms and spectrums using sensitive magnetic and electric field meters that have an AC output.
- The DNA line filter is quite effective in mitigating the dirty electricity caused by inverters.
  - This can be demonstrated by measurement of voltage and current in in the circuits of the house and the DNA line filters.
  - This can also be demonstrated by measurement of ambient EMR as magnetic and electric fields.

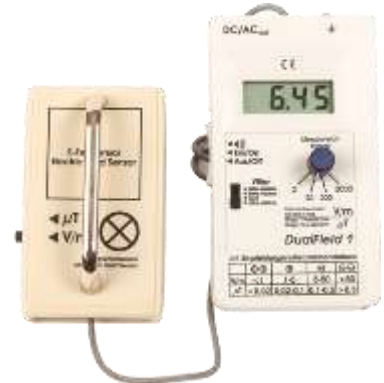
Gigahertz ME 3951A B and E Field, frequency ranges 5 to 400KHz and 2K to 400KHz

- ROM Dual Field 1, frequency ranges 10 to 400KHz and 2K to 400KHz

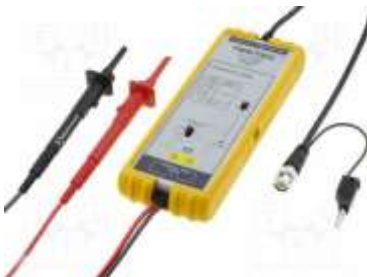
- Testec TT-SI 9002 Active Differential Probe

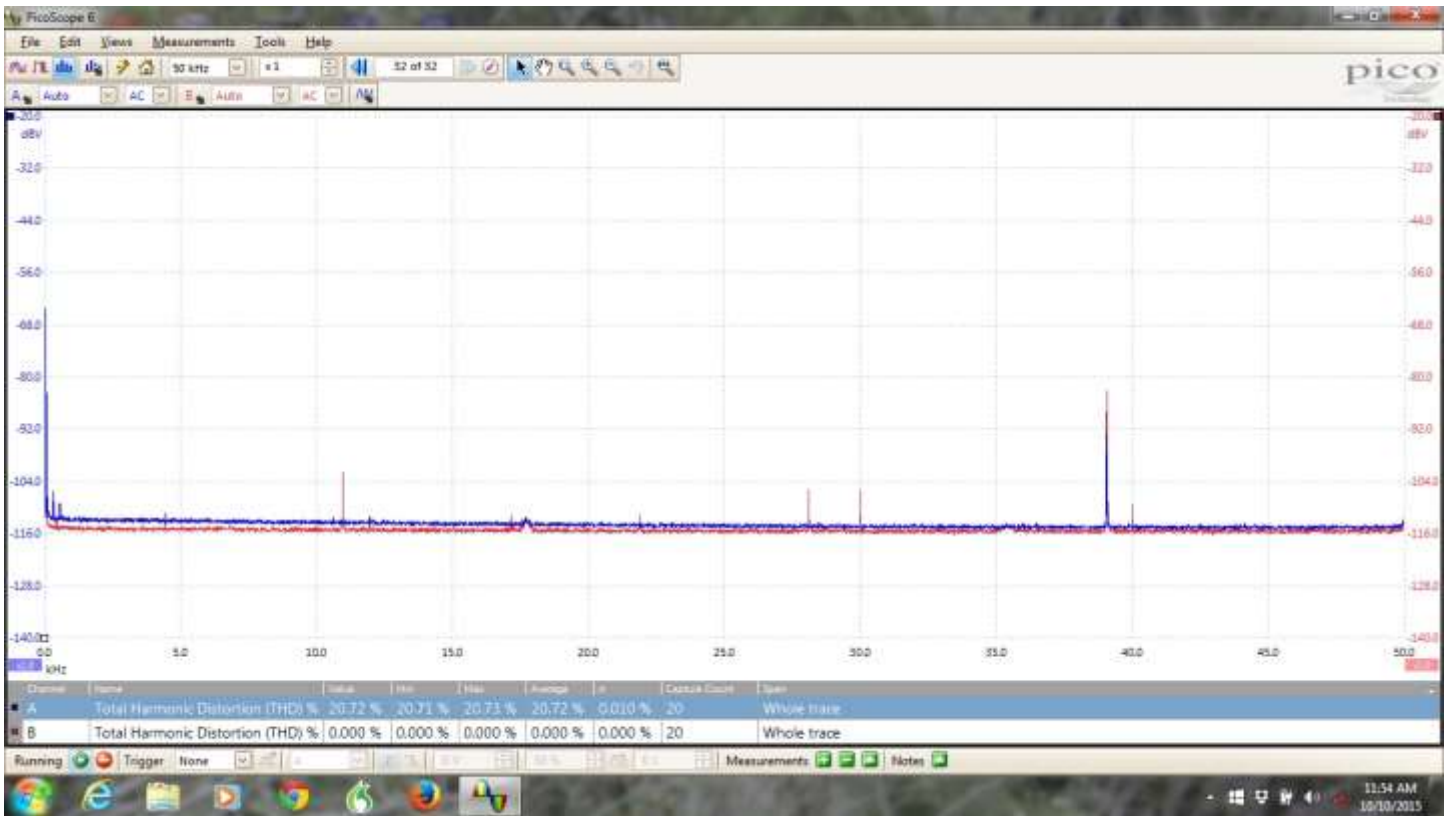
Instrument noise in measurement system, sensors off, is illustrated in the following screen.
